Geotechnical Exploration, Inc.

Job No. 19-12522

Subject: **Geotechnical Response to Neighbor Geotechnical Concerns**
Salvagio Residential Project
411 Sea Ridge Drive
La Jolla, California

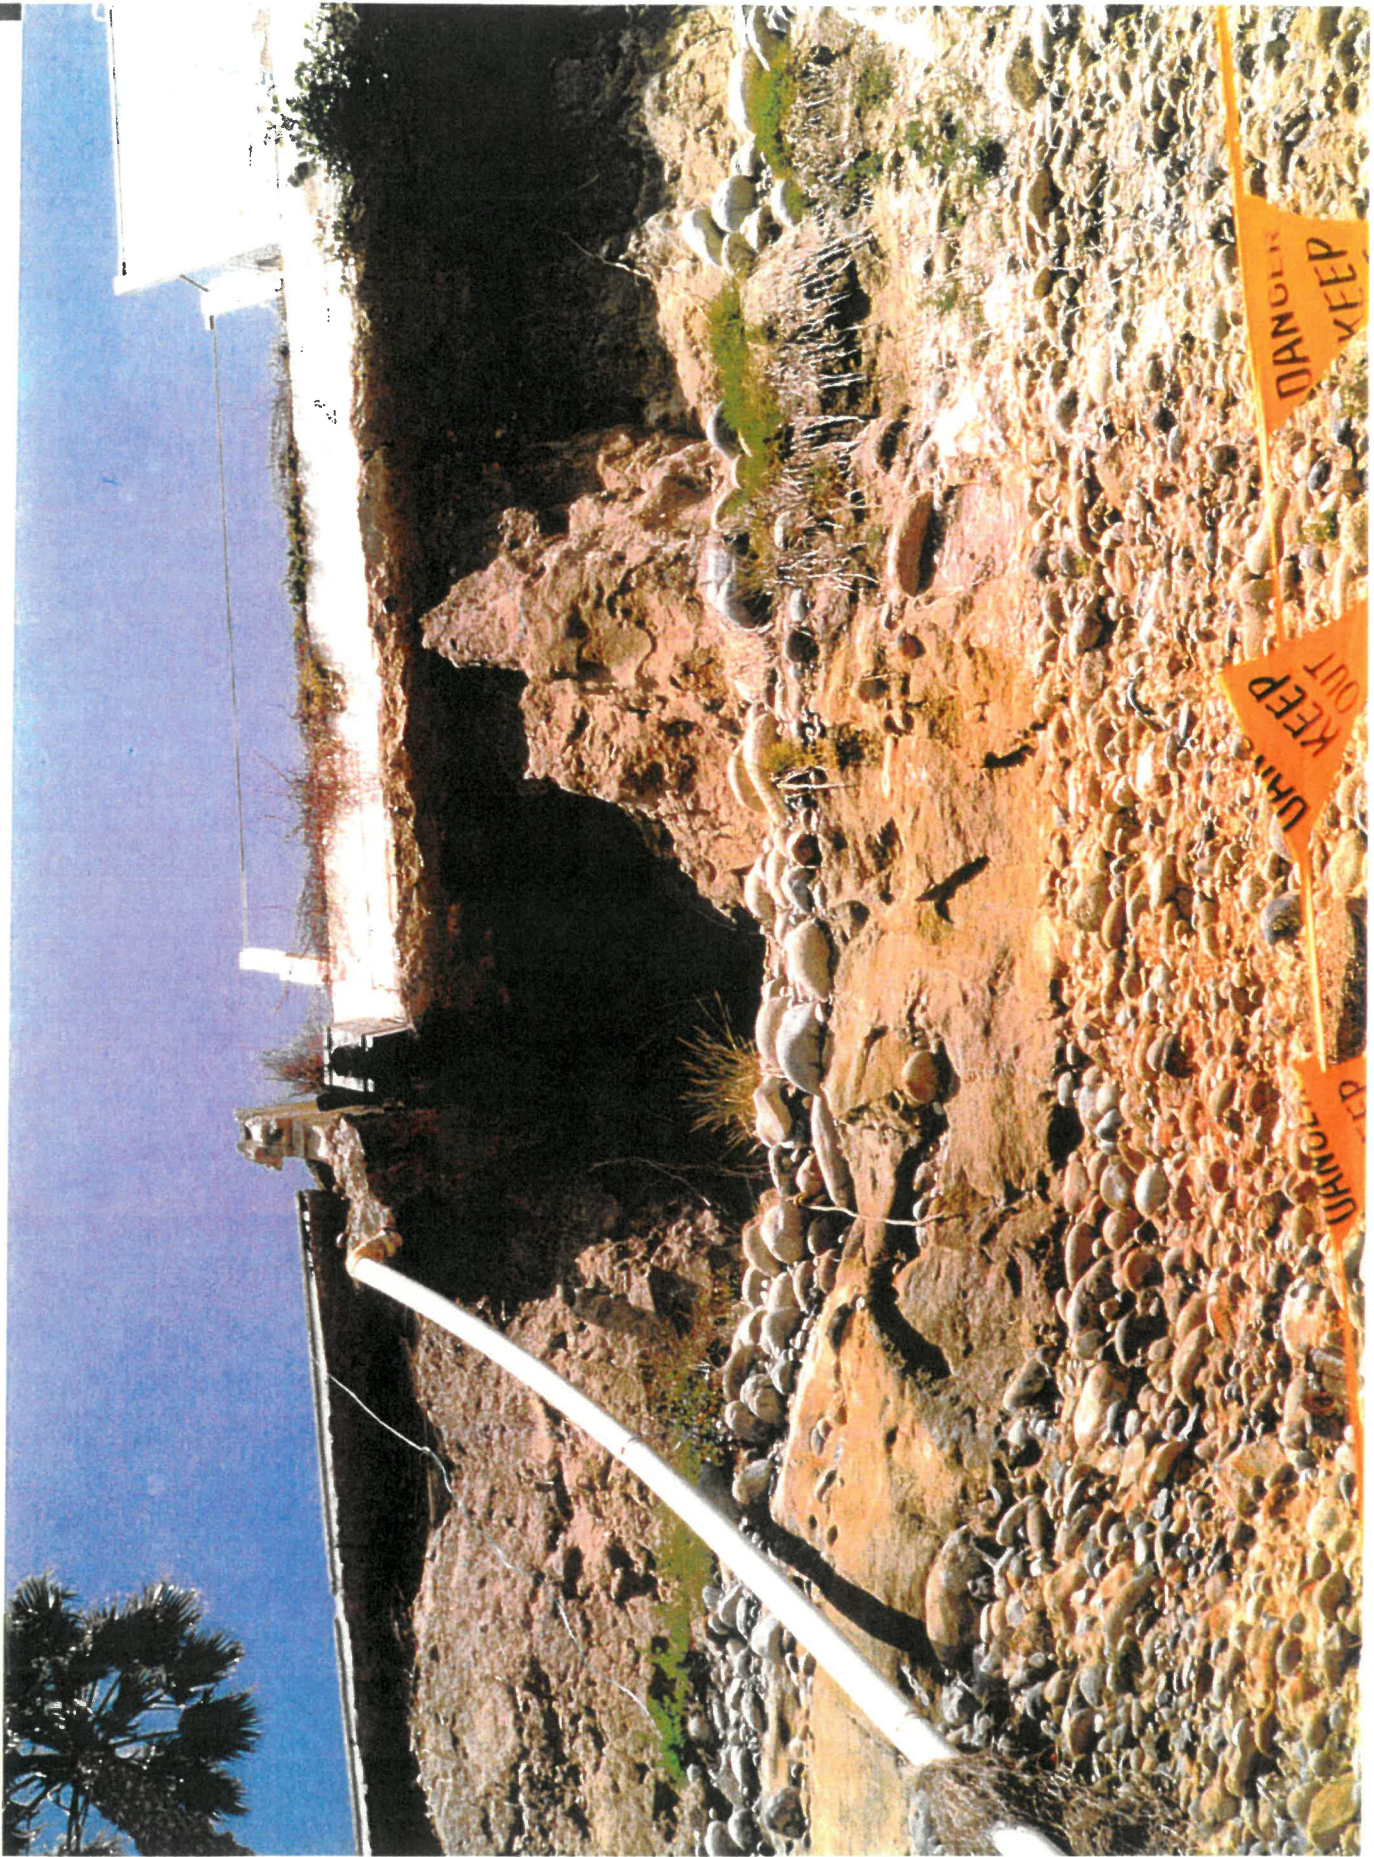
Photo D-3, taken during our on-site investigative work, shows the bluff face conditions on March 4, 2005, after the heavy rains of late February 2005. The failure encroached laterally to the west below the Wrench pool deck. As shown in the D-3 photo, the upper bluff formational soils below the deck are dry and the only wetted bluff face, top to bottom, is directly below the dysfunctional sump pump at 417 Sea Ridge. Photos D-4 and D-5, also dated March 4, 2005, clearly show the significant wetting and erosion conditions from the adverse dysfunctional sump pump water releases onto the upper bluff face. As with photo D-3, the immediately adjacent upper bluff formational soils below 411 Sea Ridge are dry.
