**PRELIMINARY
GEOTECHNICAL AND GEOLOGIC EVALUATION
FOR A PROPOSED REMODEL OF AN EXISTING RESIDENCE
LOCATED AT
7342 REMLEY PLACE
LA JOLLA, CALIFORNIA 92037**

October 4, 2019

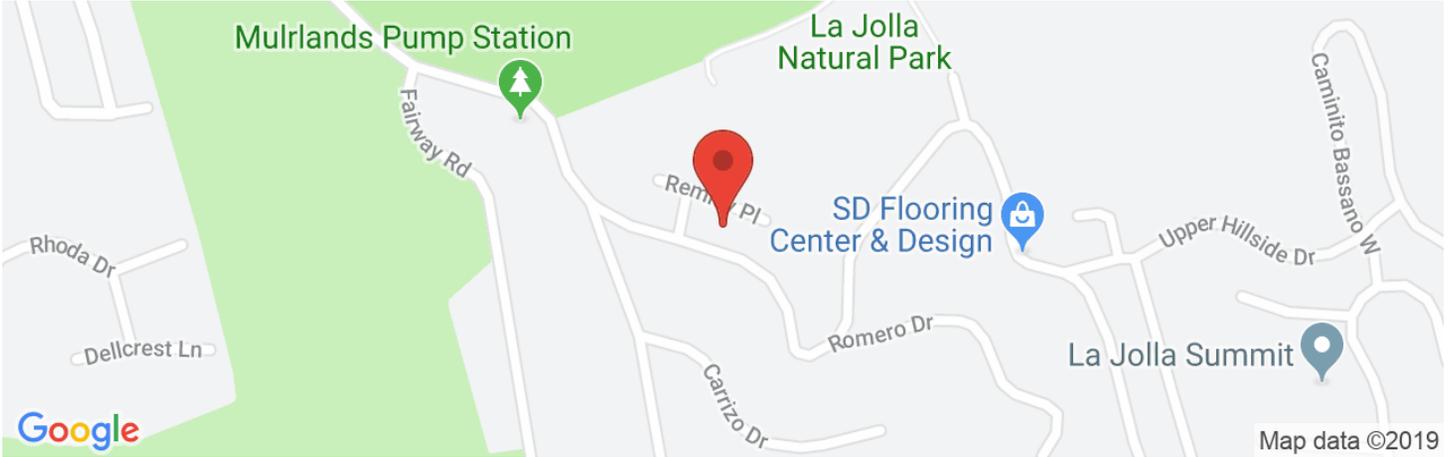
Date	10/4/2019, 7:30:43 PM
Design Code Reference Document	ASCE7-10
Risk Category	II
Site Class	D - Stiff Soil

Type	Value	Description
S_S	1.274	MCE_R ground motion. (for 0.2 second period)
S_1	0.492	MCE_R ground motion. (for 1.0s period)
S_{MS}	1.274	Site-modified spectral acceleration value
S_{M1}	0.742	Site-modified spectral acceleration value
S_{DS}	0.849	Numeric seismic design value at 0.2 second SA
S_{D1}	0.495	Numeric seismic design value at 1.0 second SA

Type	Value	Description
SDC	D	Seismic design category
F_a	1	Site amplification factor at 0.2 second
F_v	1.508	Site amplification factor at 1.0 second
PGA	0.572	MCE_G peak ground acceleration
F_{PGA}	1	Site amplification factor at PGA
PGA_M	0.572	Site modified peak ground acceleration
T_L	8	Long-period transition period in seconds
$SsRT$	1.274	Probabilistic risk-targeted ground motion. (0.2 second)
$SsUH$	1.513	Factored uniform-hazard (2% probability of exceedance in 50 years) spectral acceleration
SsD	2.458	Factored deterministic acceleration value. (0.2 second)
$S1RT$	0.492	Probabilistic risk-targeted ground motion. (1.0 second)
$S1UH$	0.563	Factored uniform-hazard (2% probability of exceedance in 50 years) spectral acceleration.
$S1D$	1.071	Factored deterministic acceleration value. (1.0 second)
PGAd	0.946	Factored deterministic acceleration value. (Peak Ground Acceleration)
C_{RS}	0.842	Mapped value of the risk coefficient at short periods

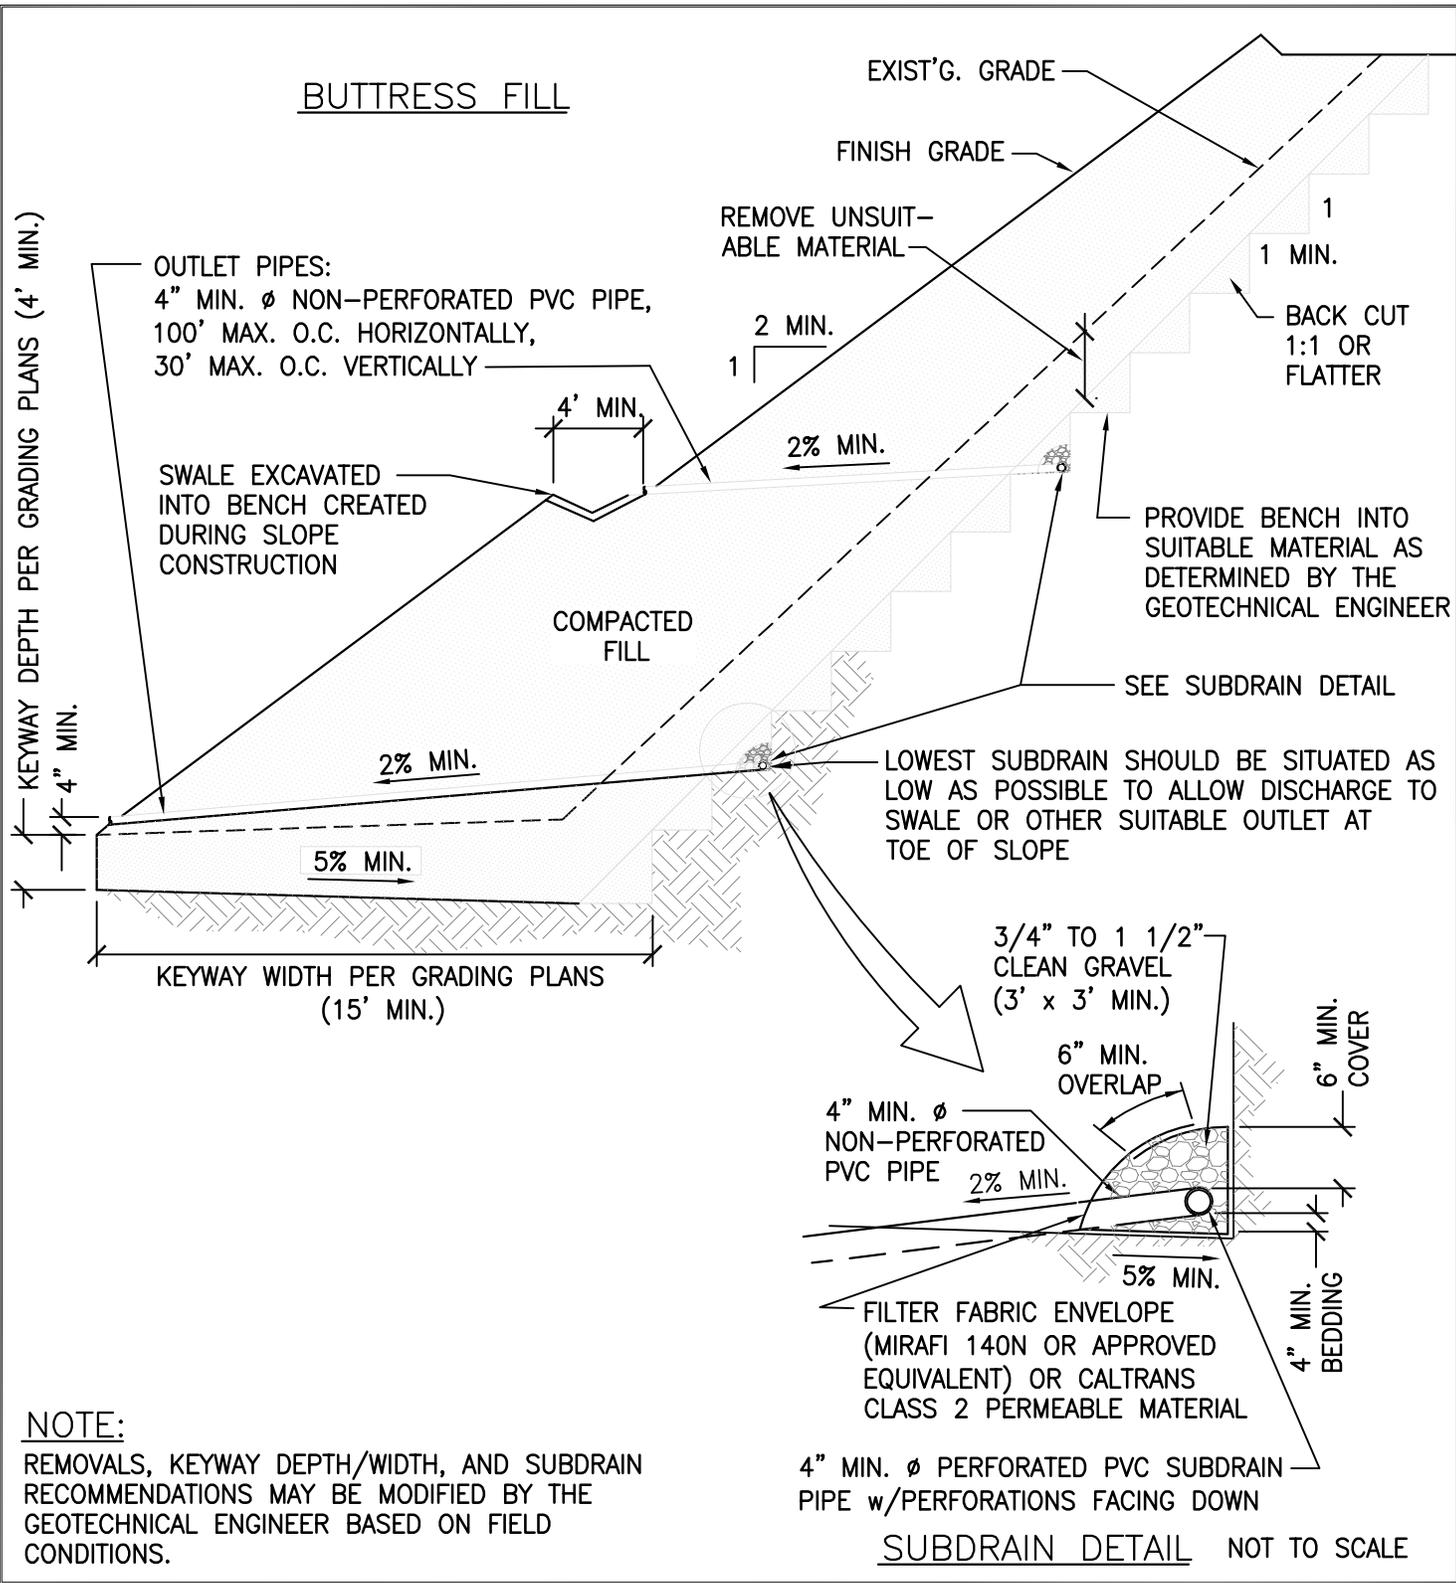
FIGURE NO.:
D-2

BUTTRESS FILL & SUBDRAIN TRENCH

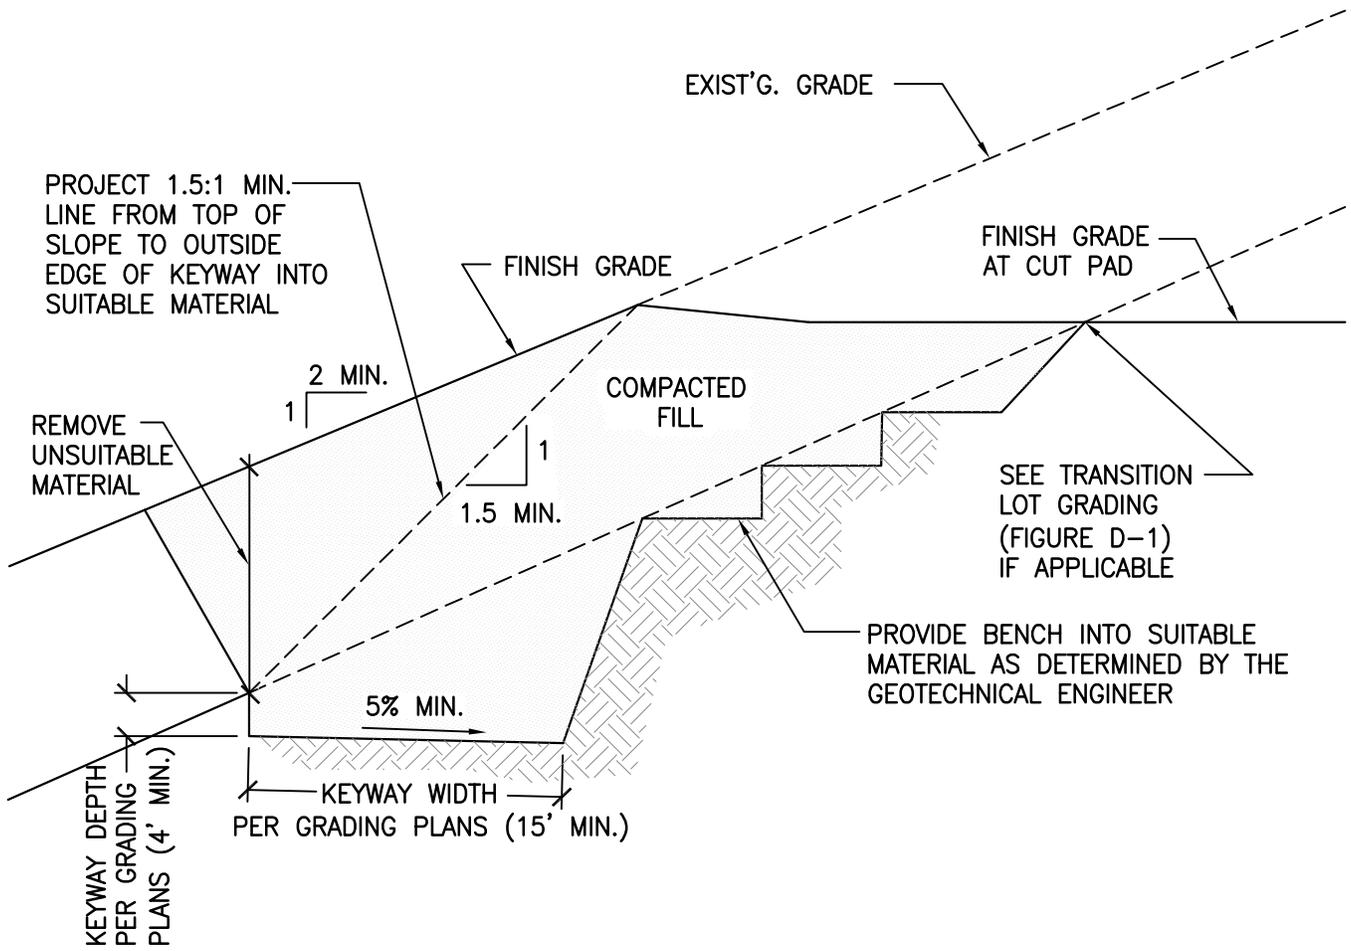
FIGURE NO.:
D-3

REMOVALS, KEYWAY DEPTH/WIDTH, AND SUBDRAIN RECOMMENDATIONS MAY BE MODIFIED BY THE GEOTECHNICAL ENGINEER BASED ON (EXPOSED) FIELD CONDITIONS.

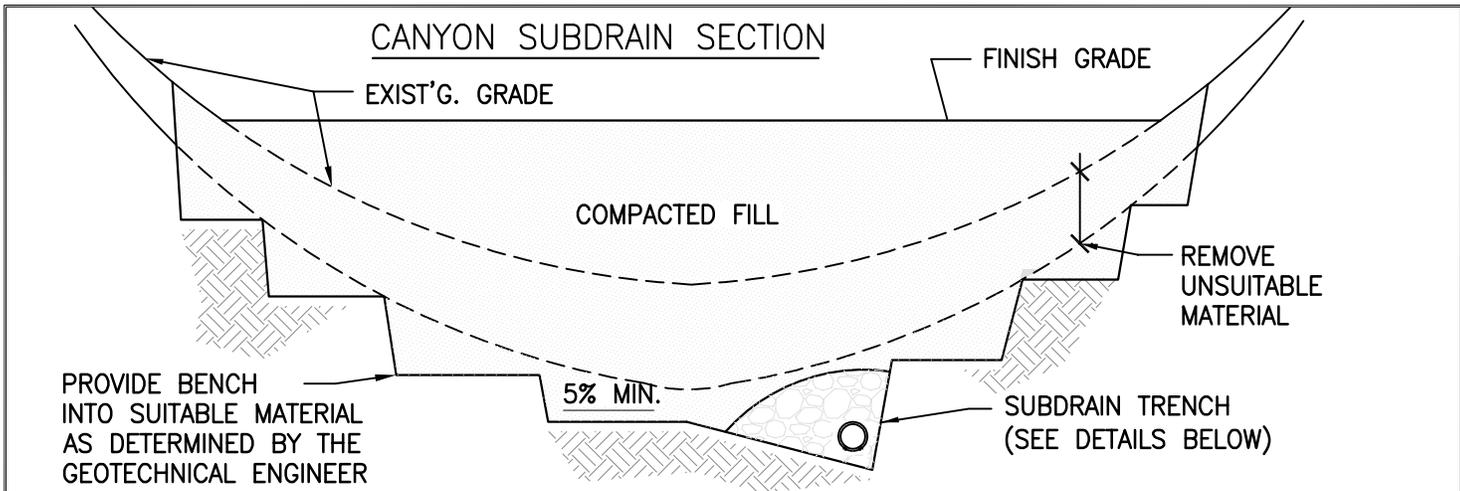
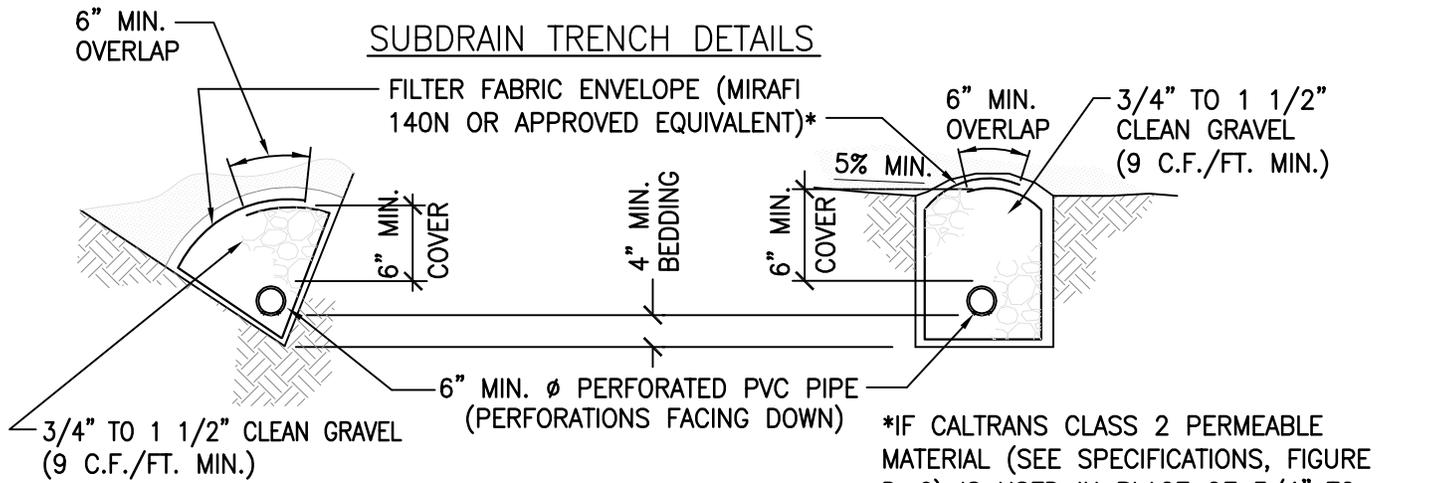
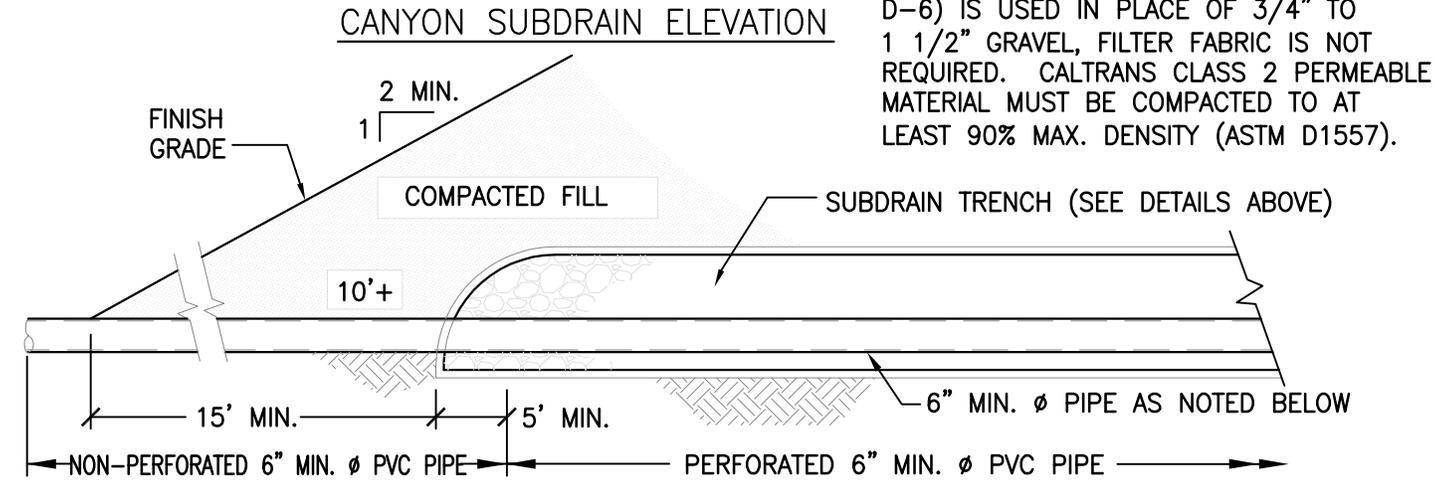
*IF CALTRANS CLASS 2 PERMEABLE MATERIAL (SEE SPECIFICATIONS, FIGURE D-6) IS USED IN PLACE OF 3/4" TO 1 1/2" GRAVEL, FILTER FABRIC IS NOT REQUIRED. CALTRANS CLASS 2 PERMEABLE MATERIAL MUST BE COMPACTED TO AT LEAST 90% MAX. DENSITY (ASTM D1557).

NOTE:
 REMOVALS, KEYWAY DEPTH/WIDTH, & SUBDRAIN RECOMMENDATIONS MAY BE MODIFIED BY THE GEOTECHNICAL ENGINEER BASED ON FIELD CONDITIONS. NOT TO SCALE

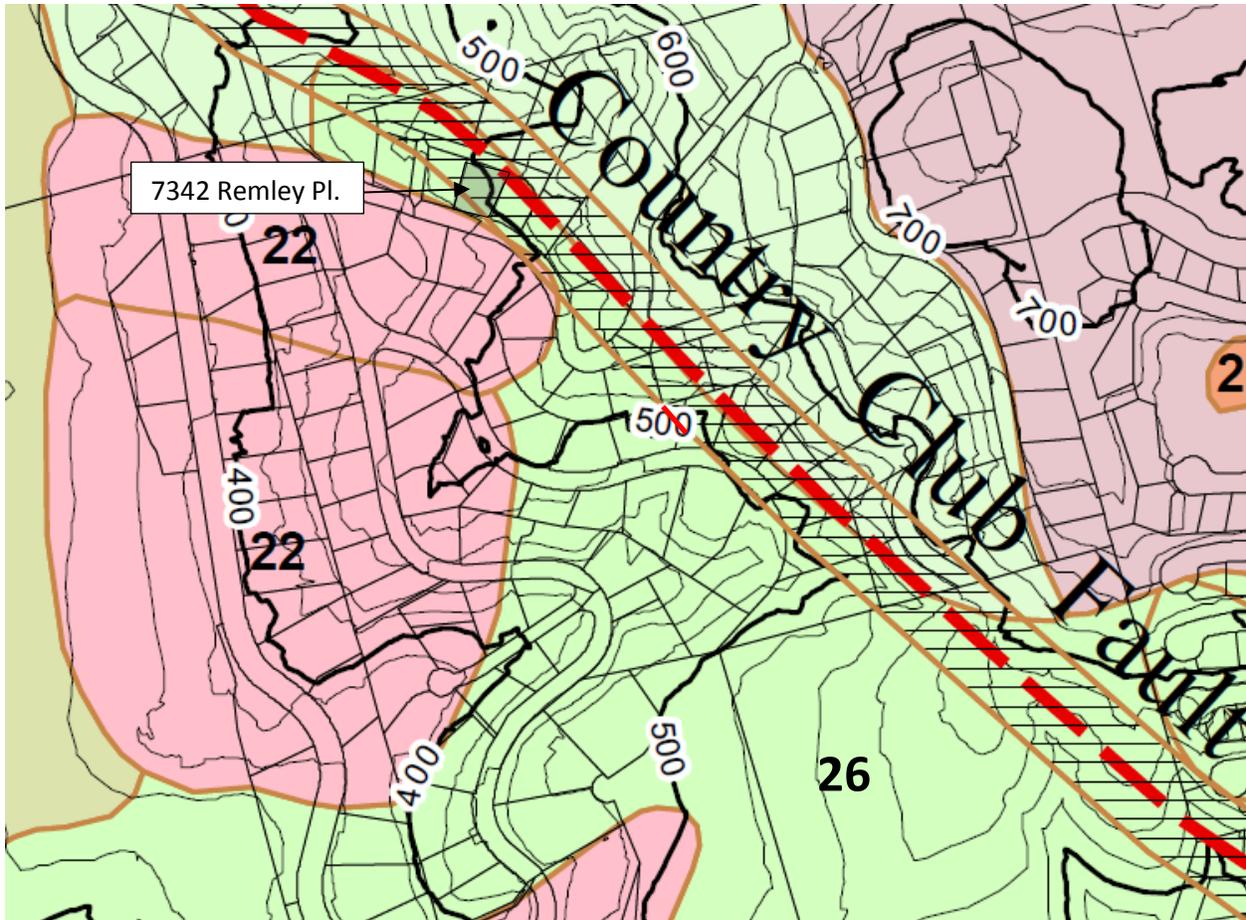
**SEISMIC SAFETY STUDY MAP SHOWING
GEOLOGIC HAZARDS AND FAULTS FOR THE
COUNTRY CLUB AREA OF LA JOLLA, CALIFORNIA**

(reference: City of San Diego Seismic Safety Study Map 29)

- 22: Possible or conjectured landslide
- 26: Ardath Shale, unfavorable geologic structure

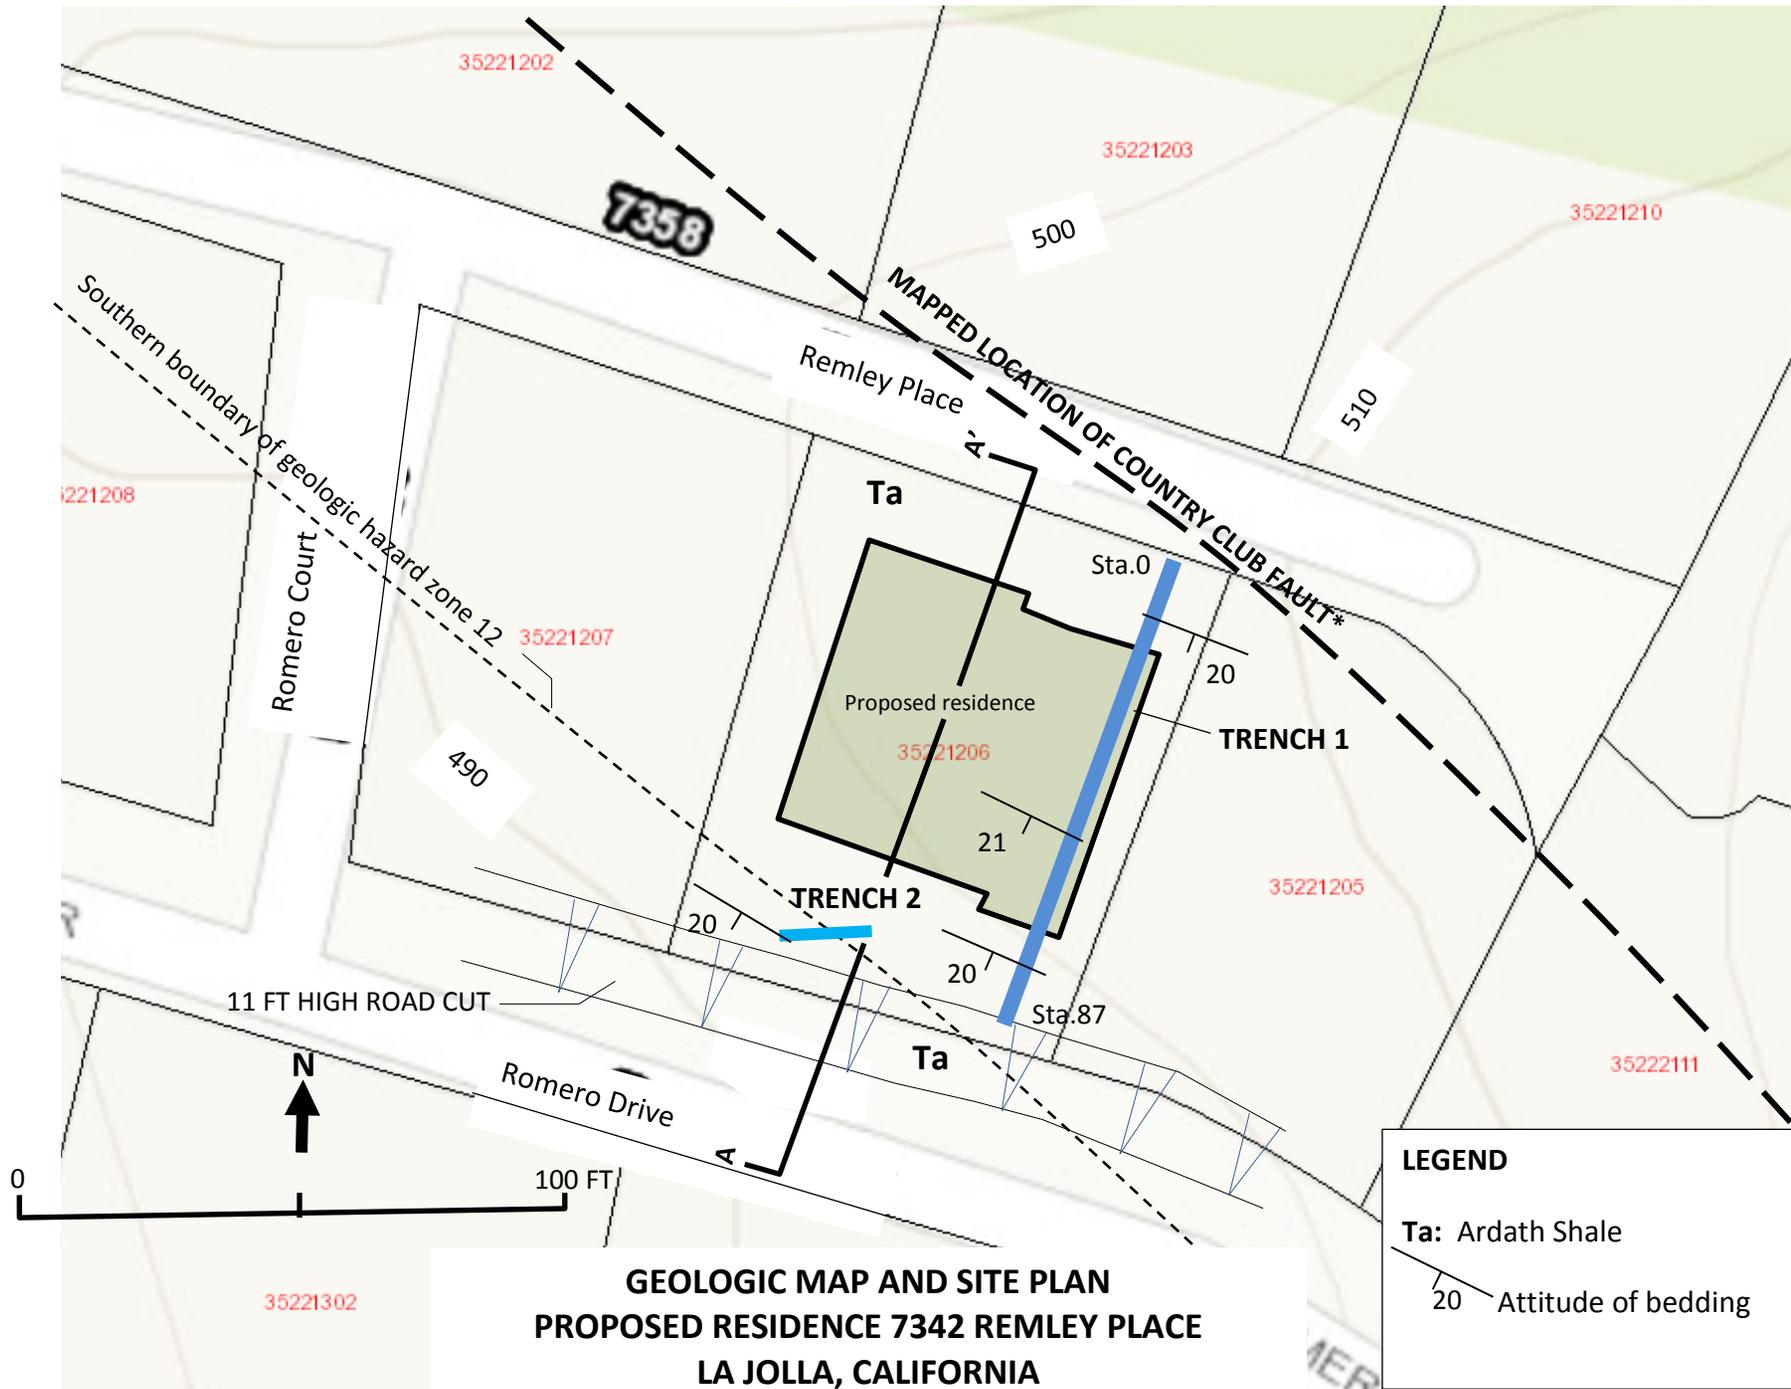
**GEOLOGIC MAP AND SITE PLAN
 PROPOSED RESIDENCE 7342 REMLEY PLACE
 LA JOLLA, CALIFORNIA**

*fault location after Kennedy (1975) and City of San Diego Geo. Haz. Map 29

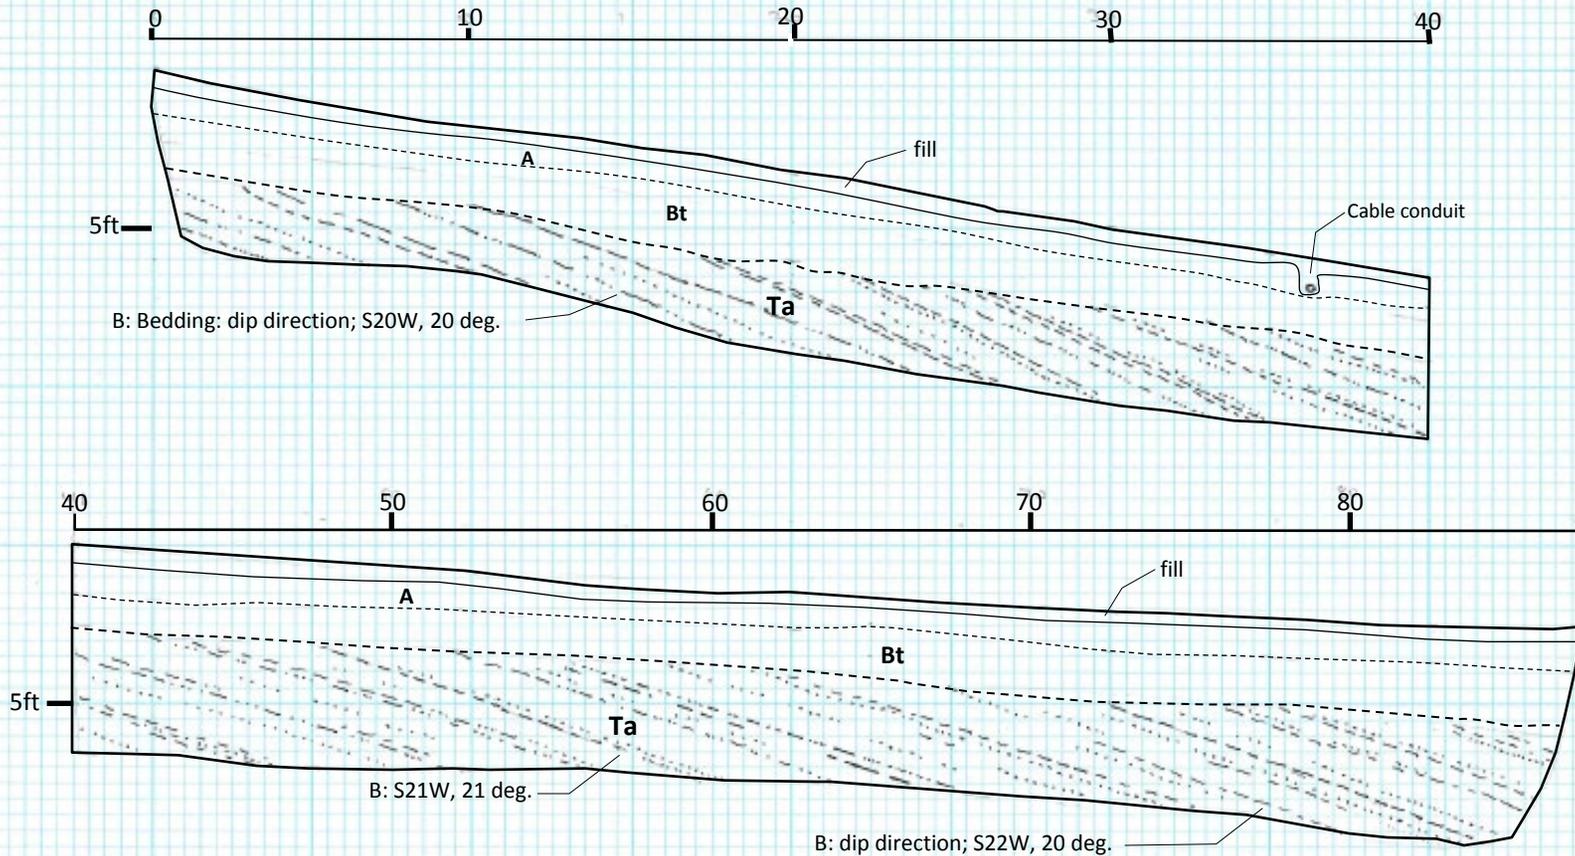
TRENCH 1

7342 REMLEY PLACE, LA JOLLA, CALIFORNIA

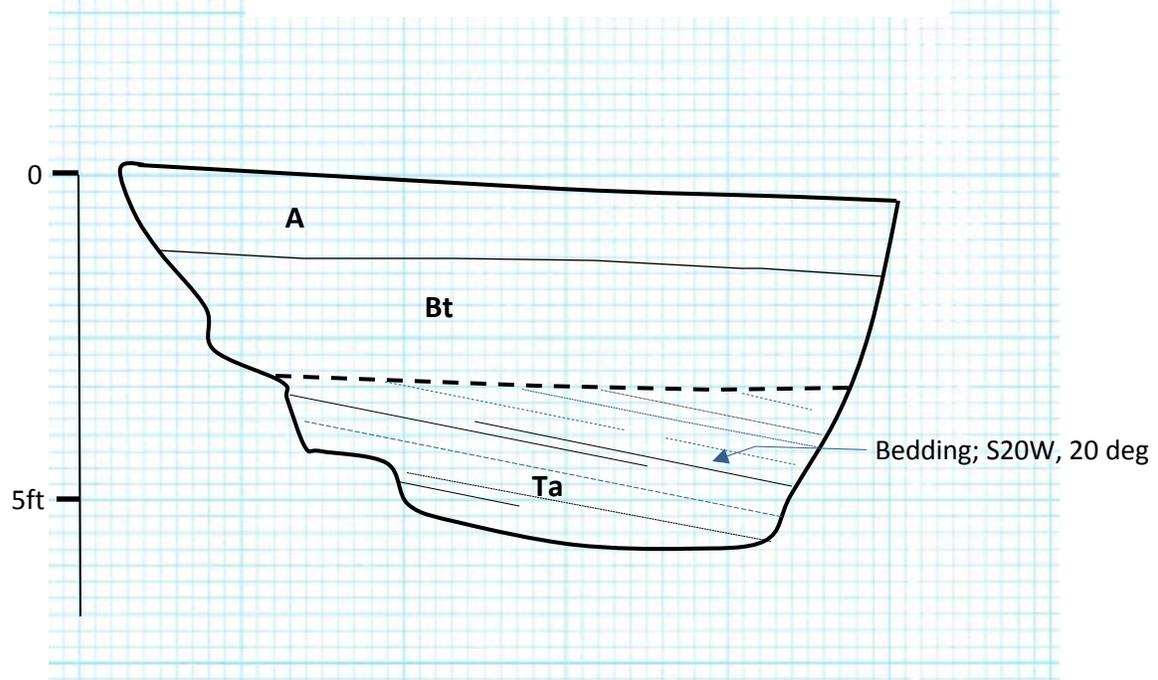
TRENCH 2

Bt: Argillic horizon, stiff, moist, dark brown clay
Very well developed, uniform with rare carbon flecks.

Ardath Shale: Very hard, moist, lt. brown to grey clay shale and fine brown to yellow brn. silty sandstone, thinly bedded.

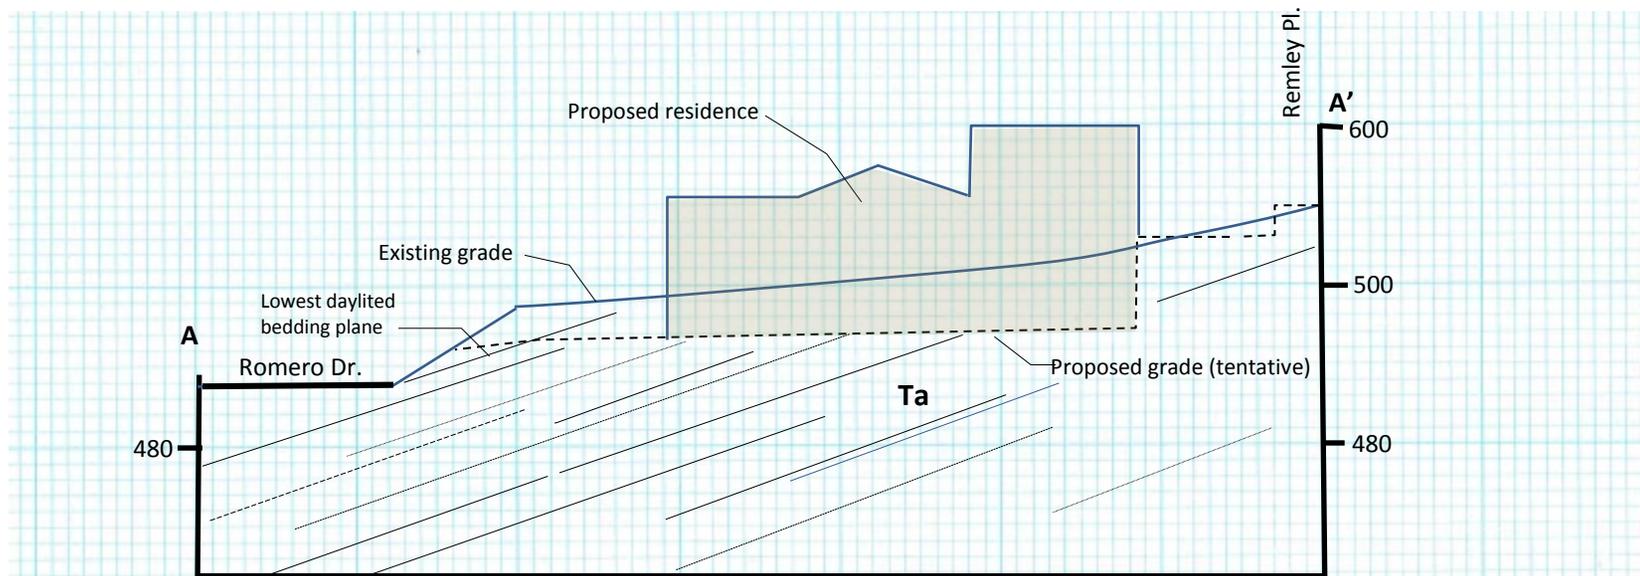
GEOLOGIC SECTION A – A'
7342 REMLEY PLACE, LA JOLLA, CALIFORNIA

Ta: Ardat Shale, hard, thinly bedded clay shale and interbeds of very fine sandstone
