From: Richard Reineman <reineman@gwrinstruments.com>
Sent: Tuesday, May 12, 2020 9:06 PM
To: emsmike@san.rr.com
Subject: RE: historical photos of 411 Sea Ridge

Thanks again for taking such a serious look at the 411 project. One thing I forgot to mention that bugs me is the statements the architect made about the east end pool-deck undercutting being due to a “one time occurrence due to poor pool drain maintenance at 417”. I will describe this drain situation in more detail:

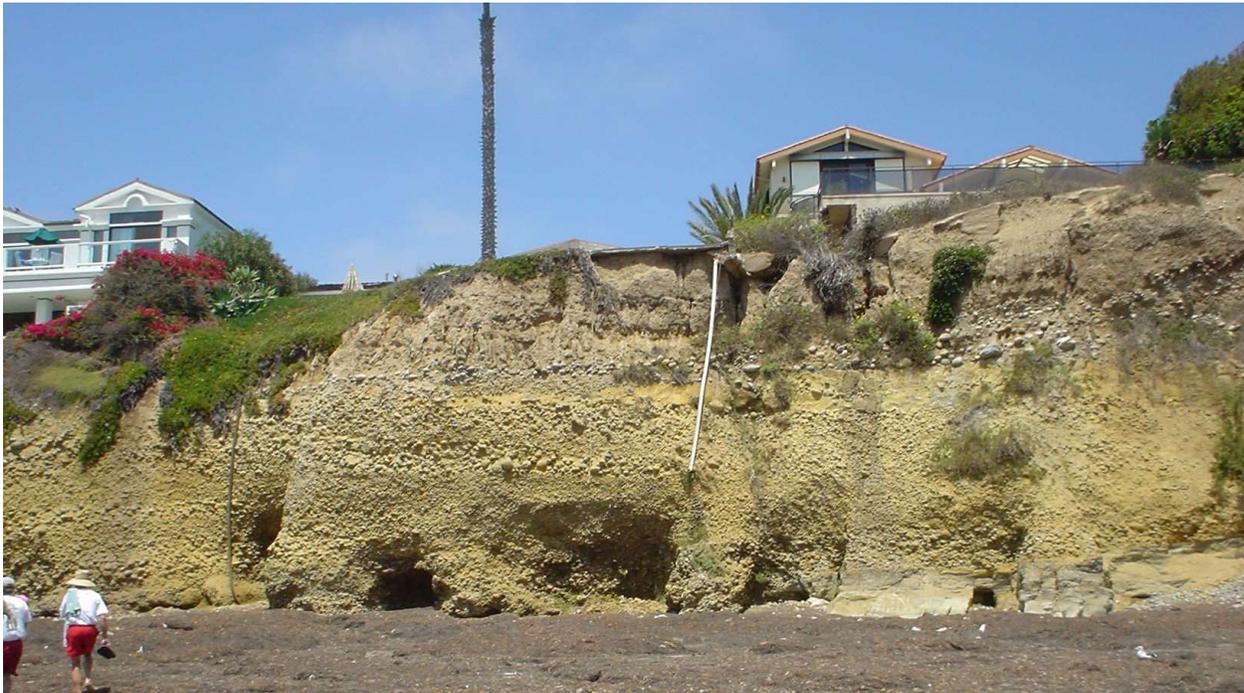
There is an on-going seepage problem due to the “underground stream” that exits the ocean cliff approximately between the two properties . Ed Wrench admitted to me some years ago before he died, about how they had bulldozed over the stream bed so they could build their house at 411 without regard to the natural watershed in the area. Ed stuck a few 4” PVC drain pipes into the ground horizontally and diverted what water he could collect over the bluff.

Added by Mike Costello Please note the white drain pipe from 411 Sea Ridge, also note the erosion between 411 and 417 Sea Ridge. Photo taken 8 Aug 2004 by Mary Lynn Hyde.

It is probably irrelevant for the purposes of the new 411 structure permitting but I do not want the new owners to be under false pretenses regarding the source of seepage on their east property line, as it will affect their long term bluff integrity. Maybe they need to consider their own sump and catchment system rather on relying only on the owners of 417 to reliably catch, and divert to the street, most of the ground water.
